Manhole Inspection Summary

Manhole # S13SS1009MH

Insp Date: **11/9/06 10:20 AM**

Location Address: **5117 SUNSET RD**

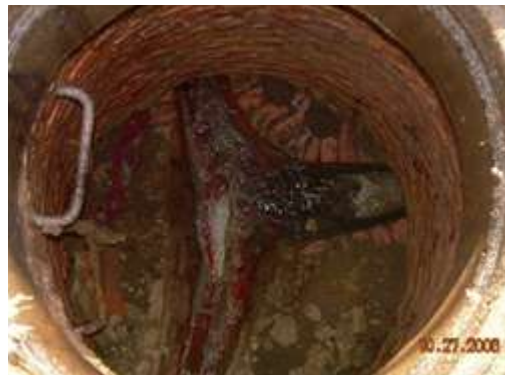
Top View

Evidence of surcharge - Bench debris.
Corroded steps. Channel debris.

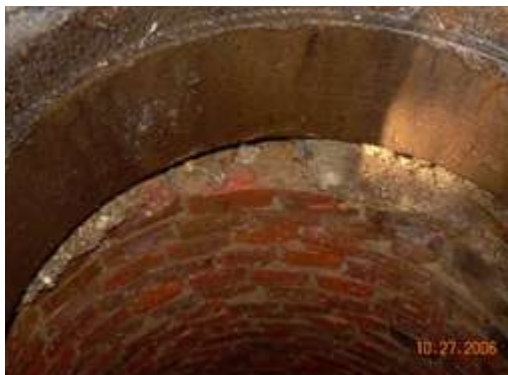
Defect

Frame leaks. Frame offset. Adjustment
deterioration and infiltration - other side.

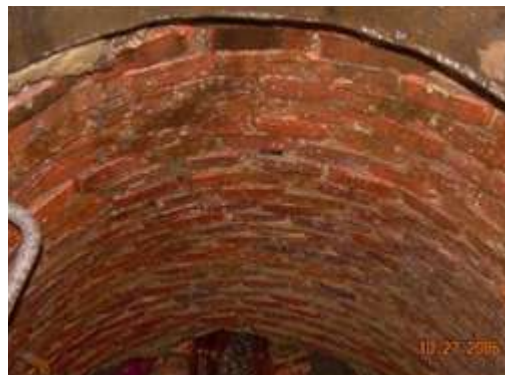
Defect

Frame leaks. Adjustment deterioration
and infiltration.

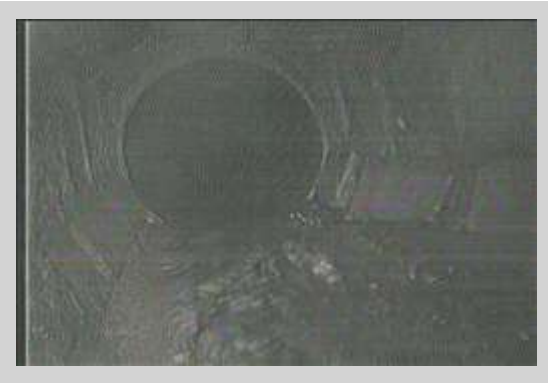
8 in. Circular Gravity Sewer Pipe Out @ 12 O'Clock

Channel deterioration.

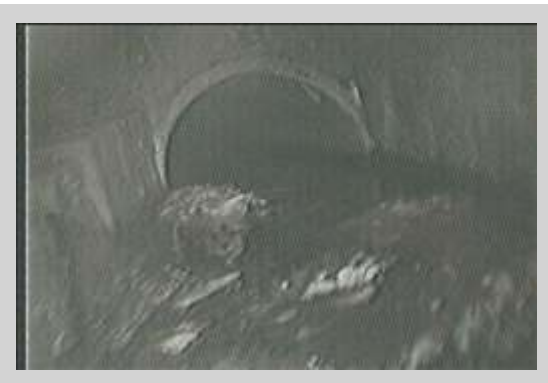
8 in. Circular Gravity Sewer Pipe In @ 3 O'Clock

Deposits: ☐ None ☐ Mud ☐ Sludge ☒ **Debris** ☐ Grease

Silt Depth: **2** (in.) Deposits Extent: **Medium**
